Manhole Inspection Summary

Manhole # S61EE_015MH

Insp Date: **3/17/10 3:52 PM**

Location Address: **Erdman Ave. Rsmg**

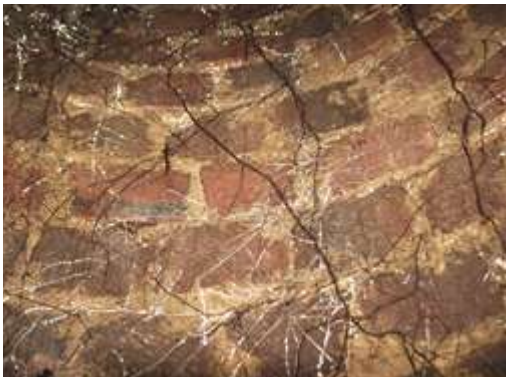
Defect 4

roots

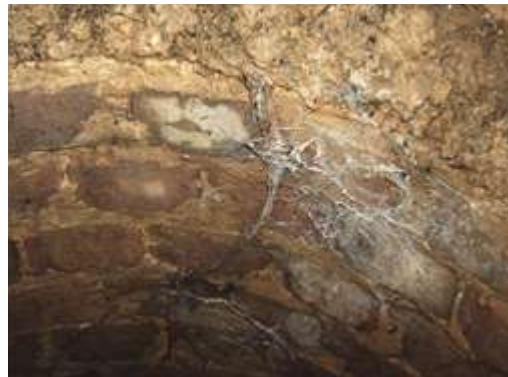
Defect 3

roots

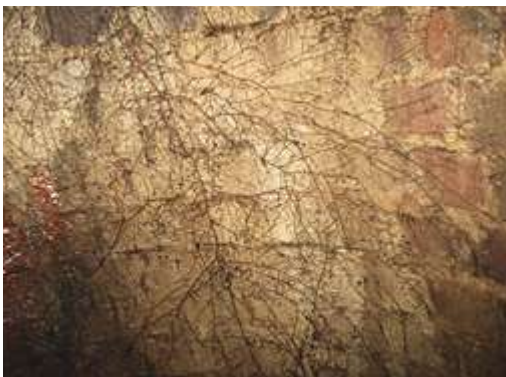
Defect 2

roots

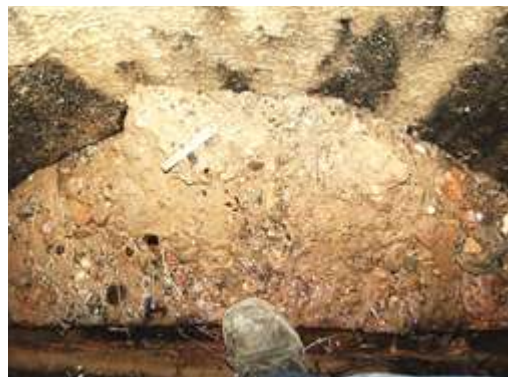
Defect 1

Condition: ☐ Sound ☐ Cracked ☐ Root Intrusion ☐ Deteriorated ☐ Leaks ☒ **Debris**

debris

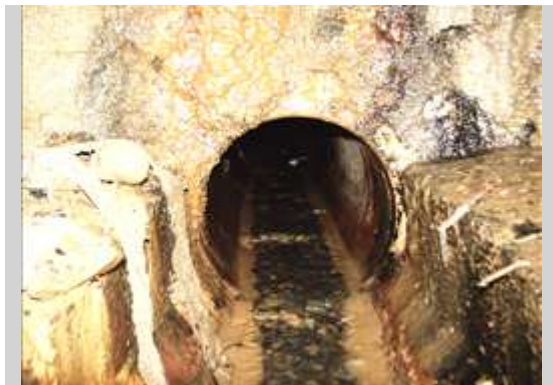
12 O'Clock Outflow

10 in. Circular Gravity Sewer
Pipe Out @ 12 O'Clock

Pipe Height: **14.4** (in.) Rod and Bar (Angled)
Pipe Material: **Clay** ☐ Pipe Lined
Invert Depth: **14.67** (ft.) Flow Characteristics: **Slow**
Deposits: ☒ None ☐ Mud ☐ Sludge ☐ Debris ☐ Grease
Silt Depth: (in.) Deposits Extent:
Infiltration: **None** Pipe Seal Cond: **Sound**

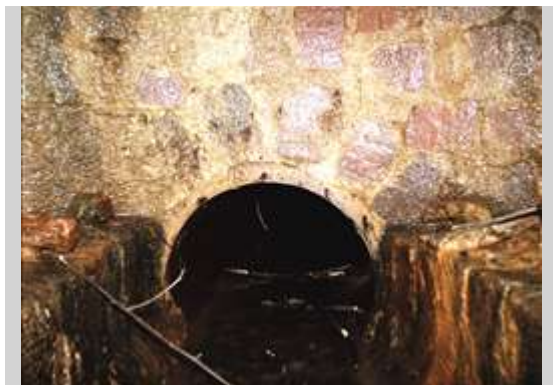
6 O'Clock Inflow

10 in. Circular Gravity Sewer
Pipe In @ 6 O'Clock

Pipe Height: **14.4** (in.) Rod and Bar (Angled)
Pipe Material: **Clay** ☐ Pipe Lined
Invert Depth: **14.58** (ft.) Flow Characteristics: **Slow**
Deposits: ☒ None ☐ Mud ☐ Sludge ☐ Debris ☐ Grease
Silt Depth: (in.) Deposits Extent:
Infiltration: **None** Pipe Seal Cond: **Sound**
